Manhole Inspection Summary

Manhole # S17WW1005MH

Insp Date: **6/10/08 10:19 AM**

Location Address: **NORTHERN PKWY**

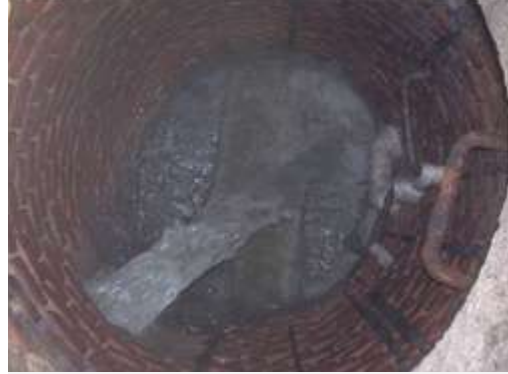
Top View

Corroded steps. Evidence of surcharge - Bench debris.

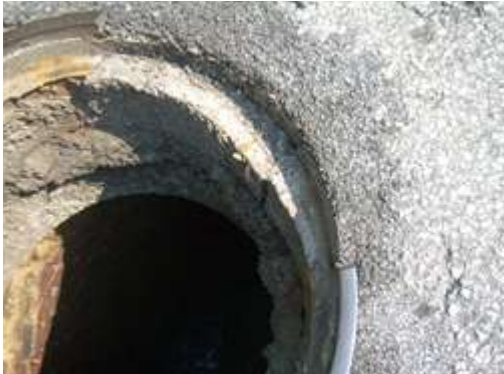
Defect

Frame leaks. Broken frame. Adjustment deterioration and infiltration.

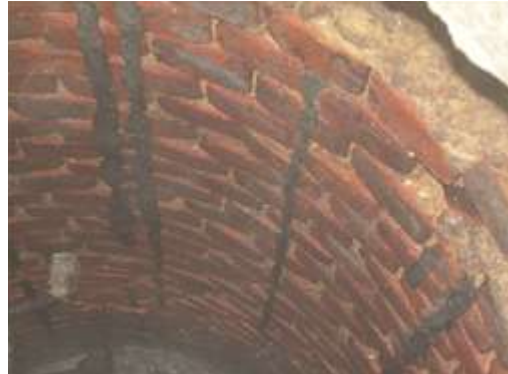
Defect

Adjustment deterioration and infiltration. Corbel and Barrel infiltration.

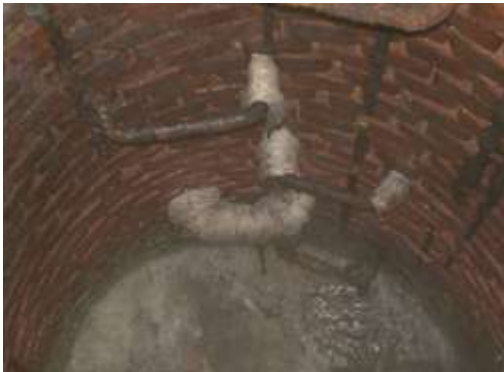
Defect

Corroded steps. Evidence of surcharge.

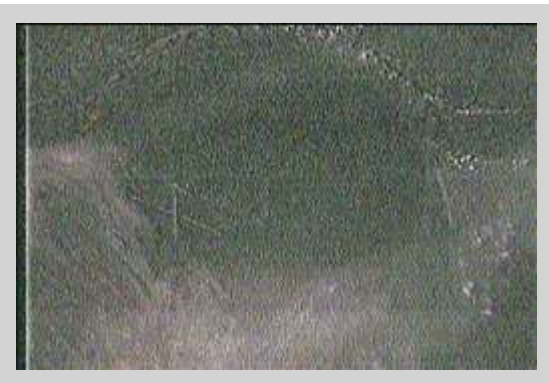
15 in. Circular Gravity Sewer Pipe In @ 6 O'Clock

Infiltration: **None** Pipe Seal Cond: **Cracked**

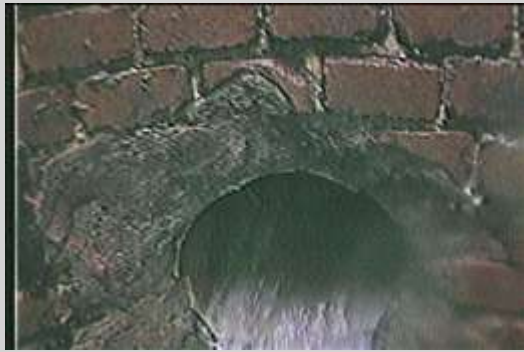
Pipe In @ 7 O'Clock

Barrel deterioration and infiltration.

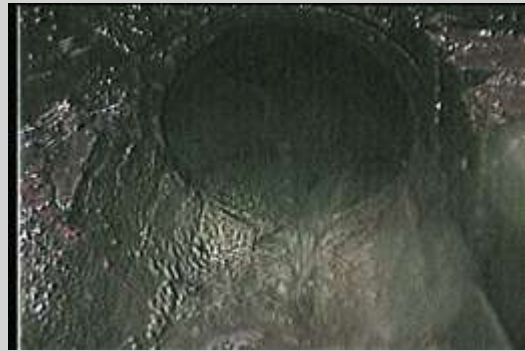
Drop In @ 7 O'Clock

Infiltration: **None** Pipe Seal Cond: **Broken**

Drop Condition: **Partly Clogged**
